RESEARCH ON GAS PLATED REFRACTORY METAL COATINGS
FOR LIQUID METAL COMPATIBILITY INVESTIGATION

San Fernando Laboratories

TECHNICAL REPORT AFML-TR-66-72

April 1966

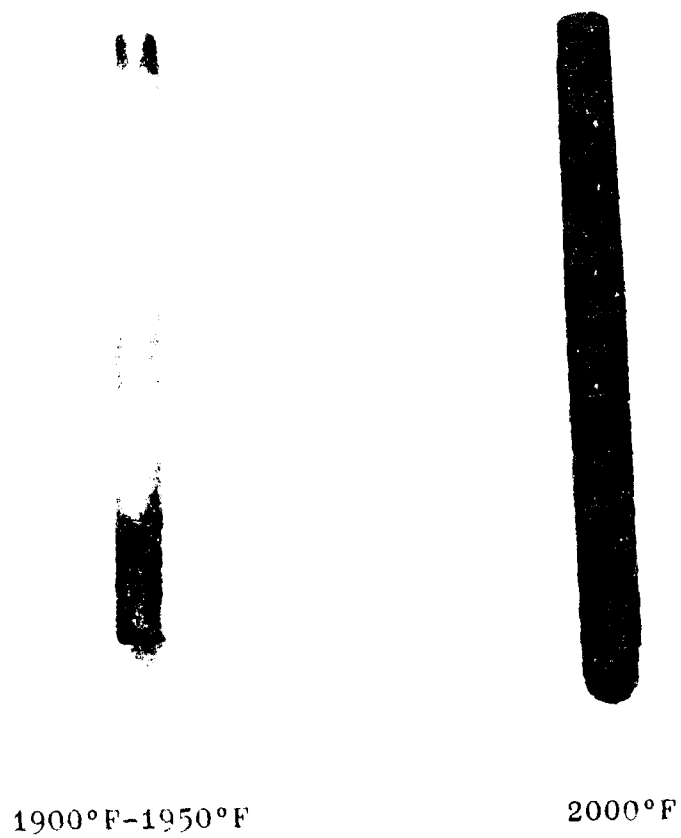
FIGURE 1

Figure 1 shows two specimens, as-plated, that were prepared at excessive temperatures. The specimen to the left was at a suitable plating temperature everywhere but at the center, which operated at over 1900°F. A coarser grain is apparent in the central portion of the specimen. The specimen to the right suffered an excursion to 2000°F in the central portion; severe coarseness is evident.

COLUMBIUM DEPOSITS FROM BROMIDE SYSTEM

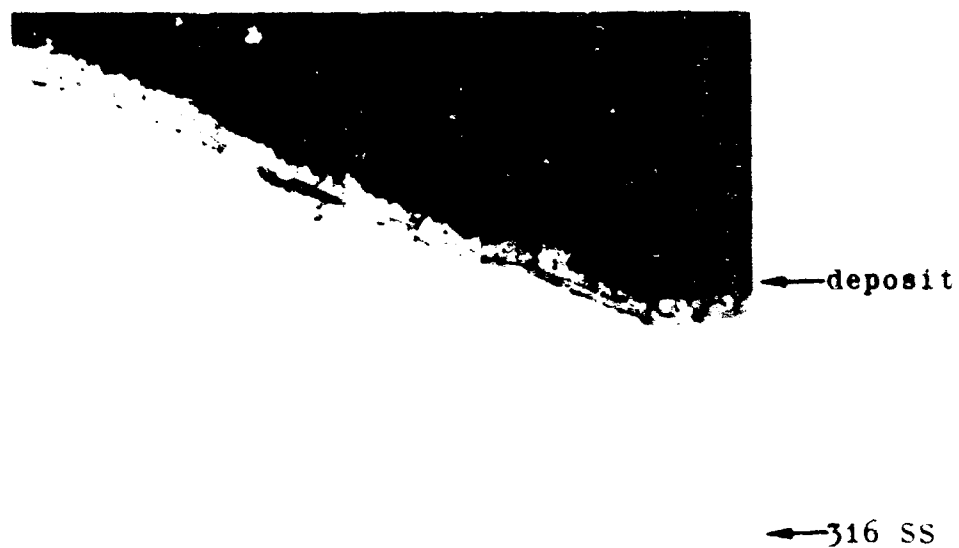
FIGURE 51

HEAT TREATED Cb-Zr INTERNAL DEPOSIT,
VICINITY OF SUBSTRATE WELD, 100X

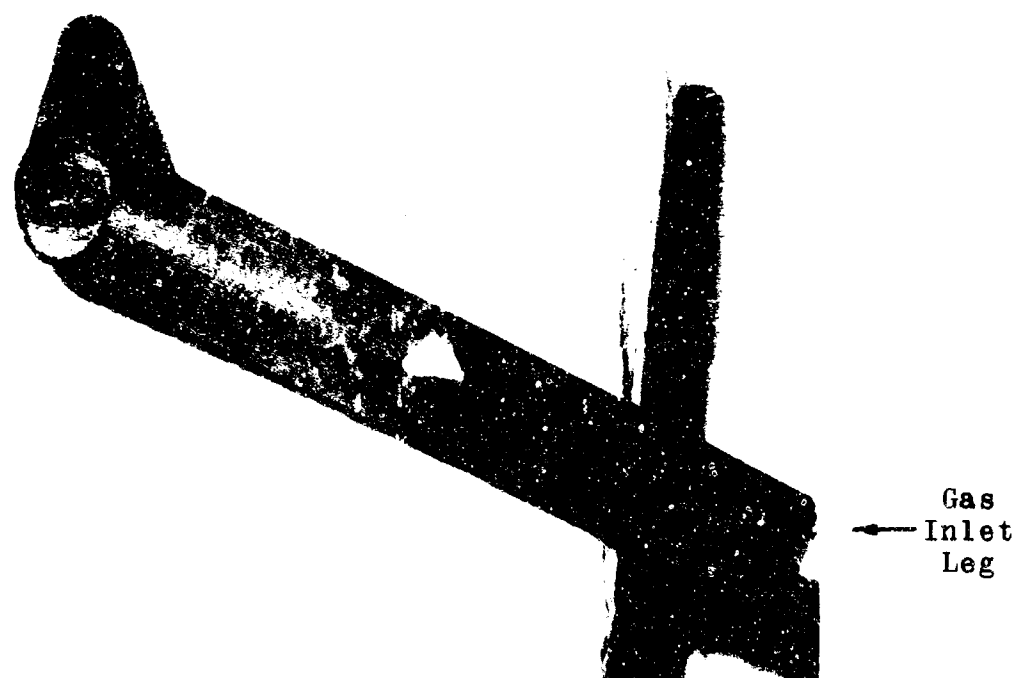
FIGURE 67

deposited metal web extending from the upstream edge of each $3/4$ inch dia. leg at the right angle junction across the 1 inch tube. This tended to seal the latter shut. Refer to Figures 67 and 68. It is believed that use of the hydrogen bleed flows, necessary in the absence of high temperature valving, was primarily responsible for this phenomenon. The geometry of the metal web seems to follow a contour of the two merging gas streams; the stream containing reactant chlorides plating along the pure hydrogen "wall".

MANIFOLD NO. 1, SECTIONED
